Site Visit Report	Project: Citizen Service Center
Location: Sar-e-Pul Province	Coordinates: Latitude: N 36° 12'58.44" Longitude: E 65° 56'14.45"
Inspection Date: October 30, 2013	Weather: Partly Cloudy, Temp @ 20°C, No Precipitation
Inspectors: [REDACTED] and [REDACTED]	Status: Complete, Transferred to Community

Ramp-UP North

**Tetra Tech, Inc.
Afghanistan Engineering Support Program
Contract No. EDH-I-00-08-00027-00
Task Order No. 1**

Work Order WO-LT-0009 AMD #5

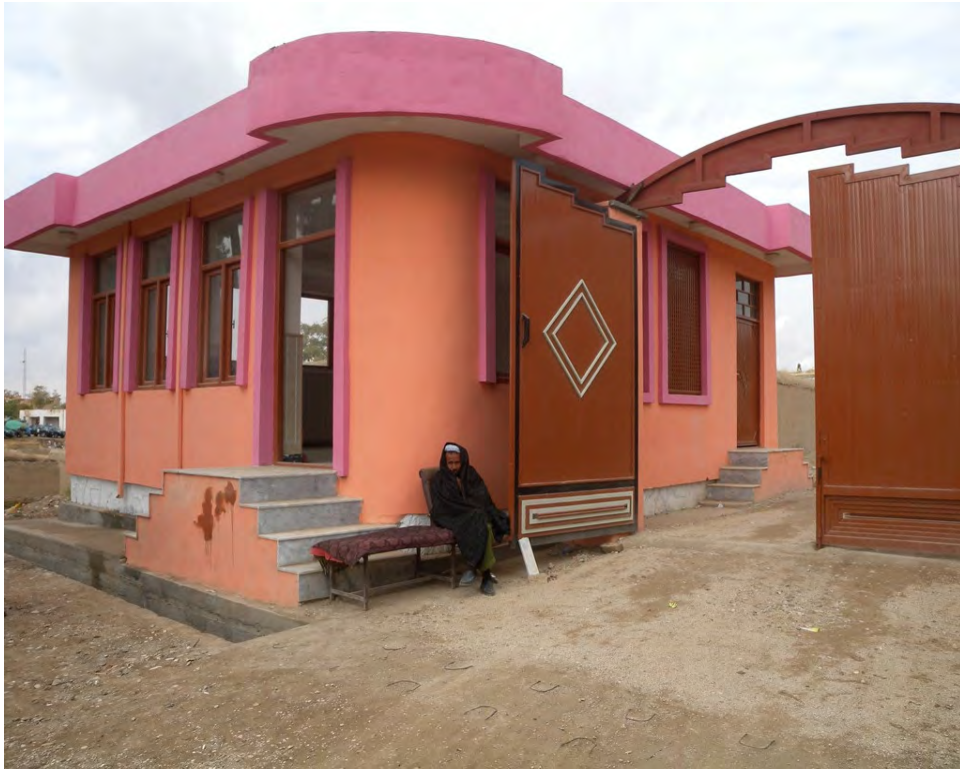
1. The stairways leading to the doors (see figures 1, 2, 3, and 4) pose a hazard for users. Tt advises that railings be installed to eliminate the hazard.

1. Construction work for the CSC building is complete. This includes stone masonry, brick masonry, concrete work, marble tiles placement and painting. (See Figures 1 and 2)

3. Installation of six (6) small windows and one (1) large window is complete. This appears to be in accordance with the architectural renderings.
4. Installation of two (2) entry doors is complete. This appears to be in accordance with the architectural renderings. (See Figures 1, 3, and 4)

7. Installation of the vehicle gate is complete. This appears to be in accordance with the architectural renderings. (See Figures 1 and 4)

Figure 1. Southwest view of CSC building

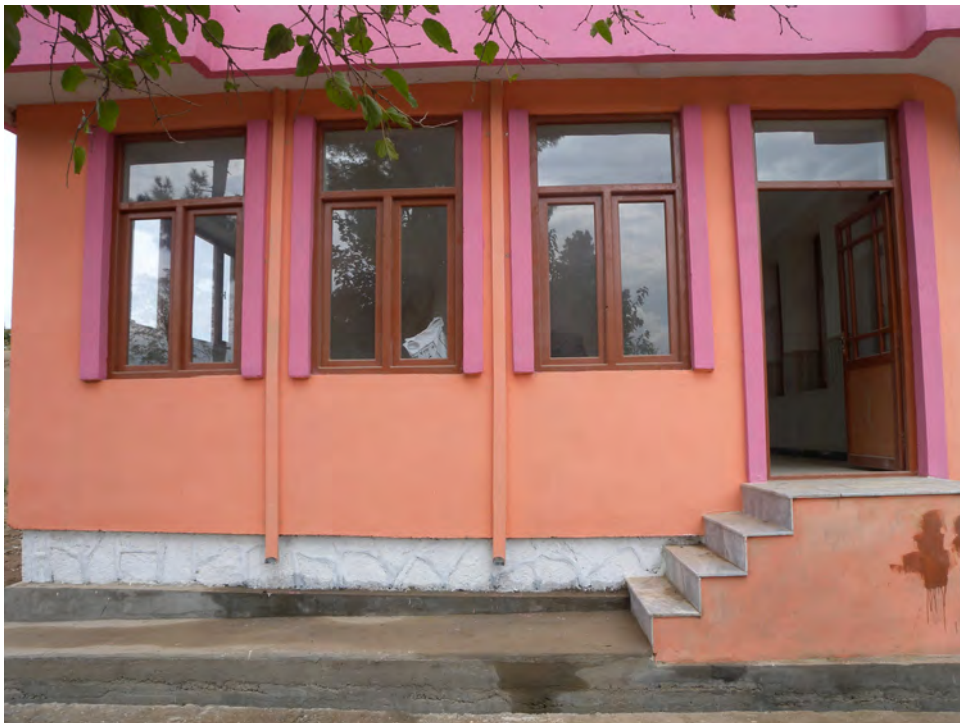
Figure 2. Northwest view of the CSC building

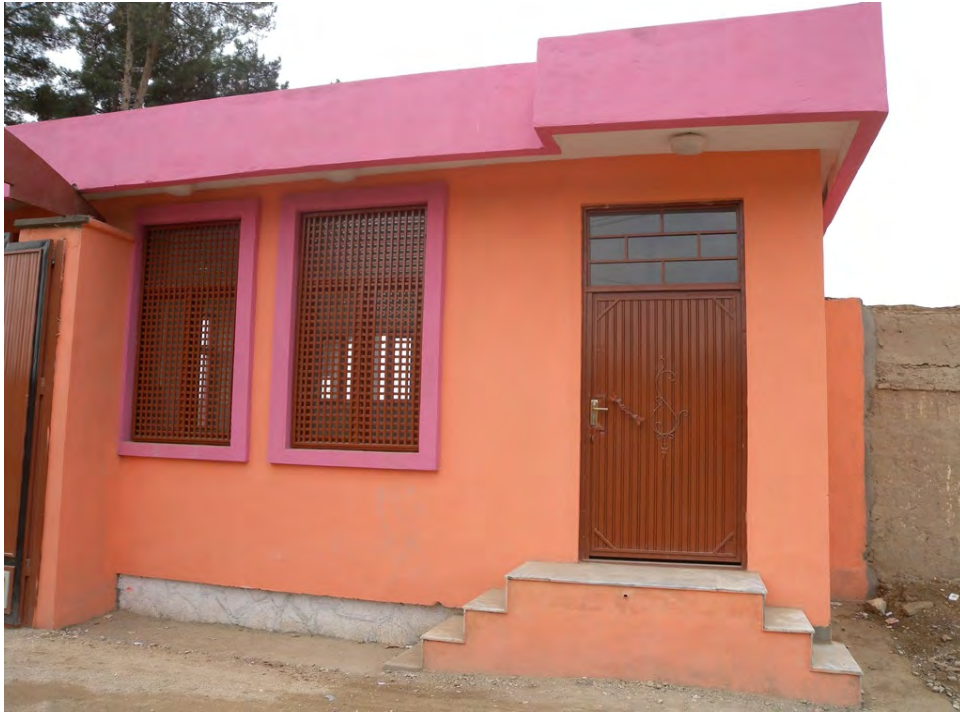
3. Installation of the steel fence and steel net is complete. The steel fence profile is 20 x 20 mm for the main frame along with decorative steel work and steel net installed for the two (2) exterior windows of CSC building for the security purpose to satisfy the items listed in the BOQ. (See Figures 3, 4, and 5)

Figure 3. View of the southwest side of the CSC building with one entry door and two windows covered with net to provide security

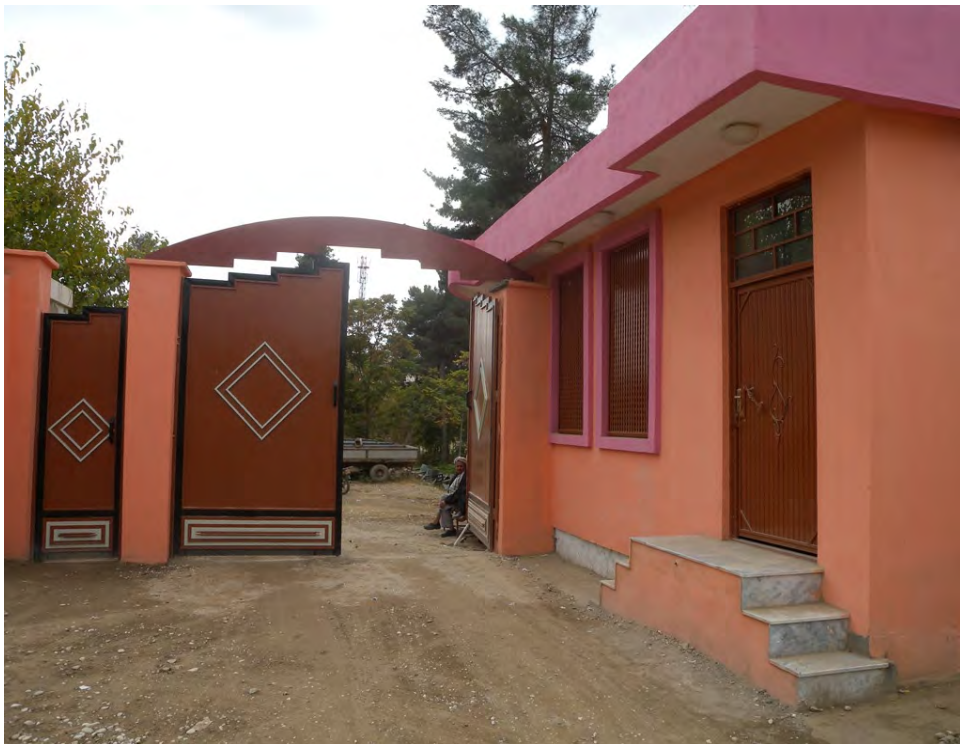
Figure 4. View of steel vehicle entry gate

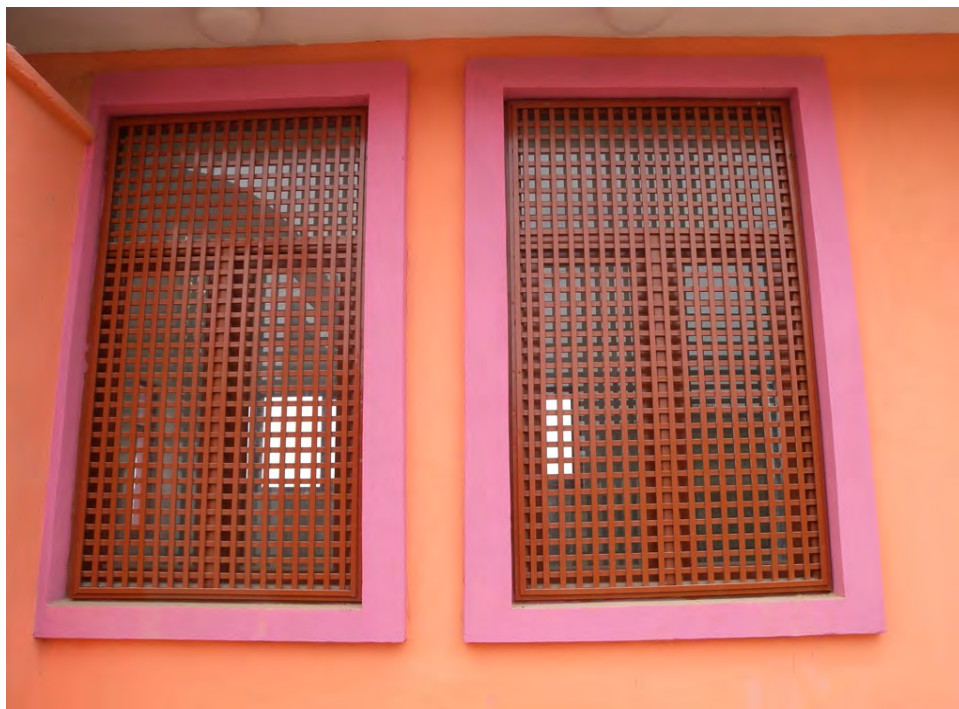
Figure 5. View of the windows, covered with net to provide security

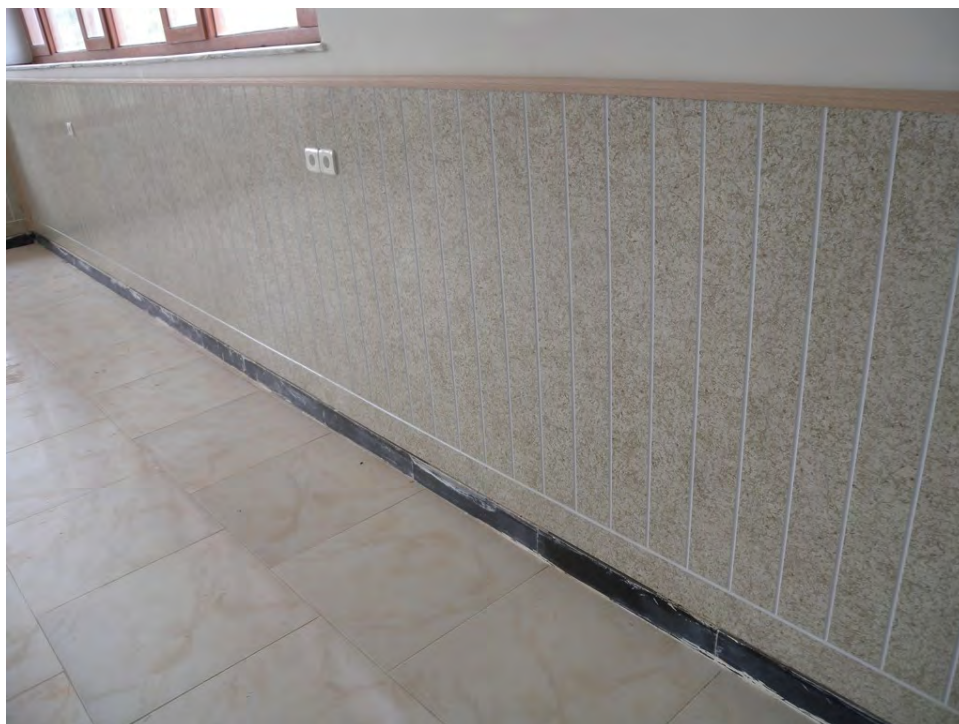
1. The installation of the Medium Density Fiber (MDF) board wainscoting is complete. It measures 120 cm and covers the lower part of the interior walls, satisfying the items listed in the BOQ. (See Figures 6, 7, 8, and 9)

Figure 6. View of wooden/MDF board (particle board), covering the lower part of the interior walls, 120 cm in height

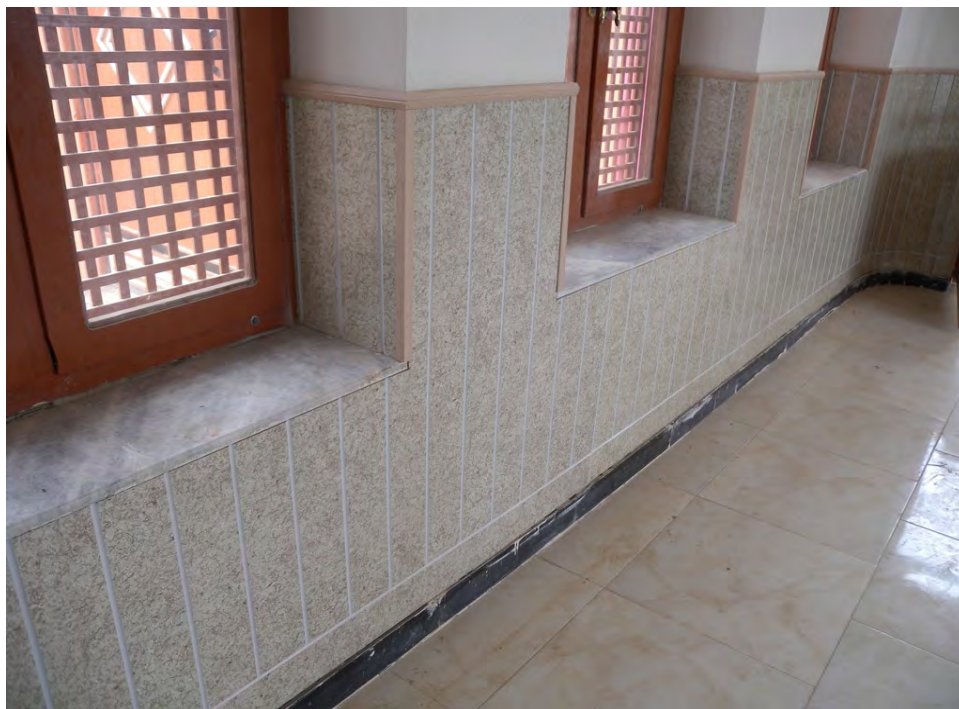
Figure 7. Another view of wooden/MDF board (particle board), covering the lower part of the interior walls, 120 cm in height

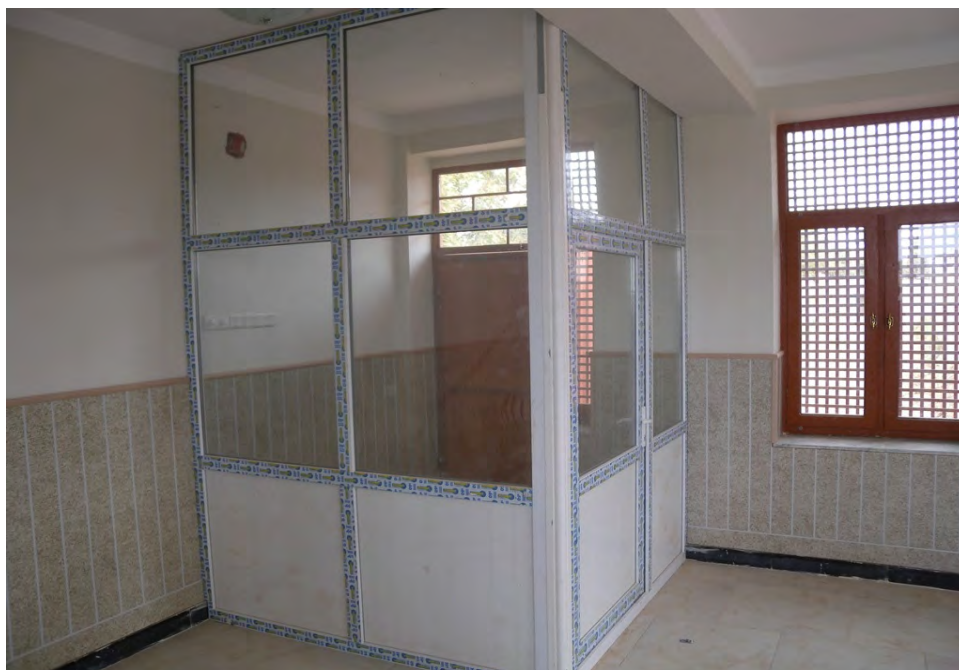
2. The installation of the cabin hall for the entry door is complete. It measures 2 m x 1.2 m x 3.1 m, satisfying the items listed in the BOQ. (See Figures 8 and 9)

Figure 8. View of the PVC Cabin hall for entry door

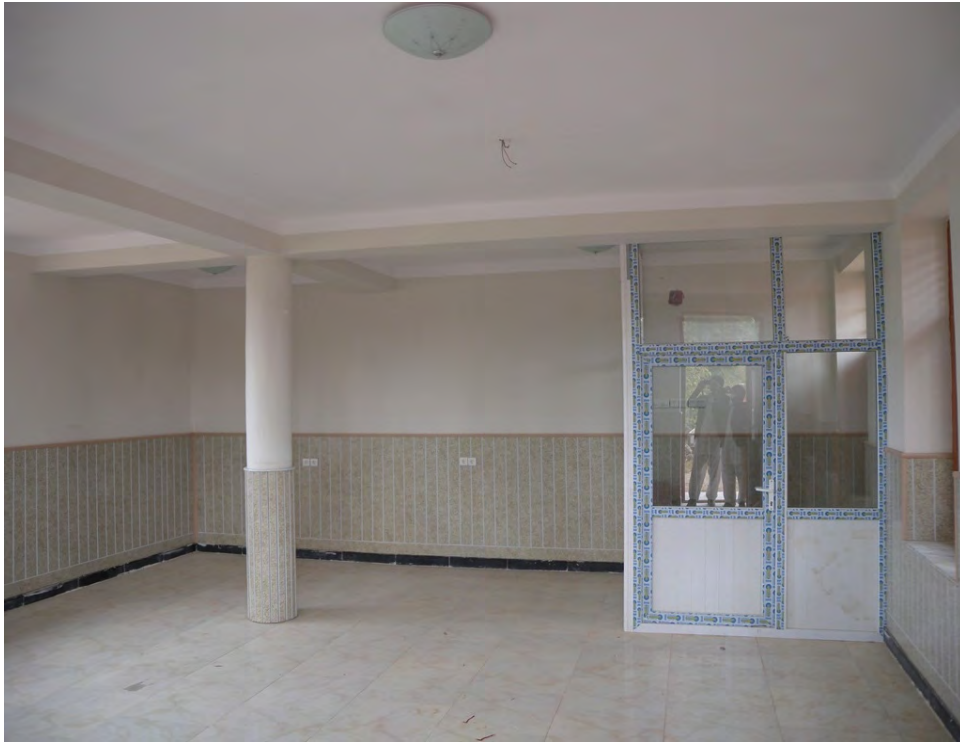
Figure 9. Interior of the CSC

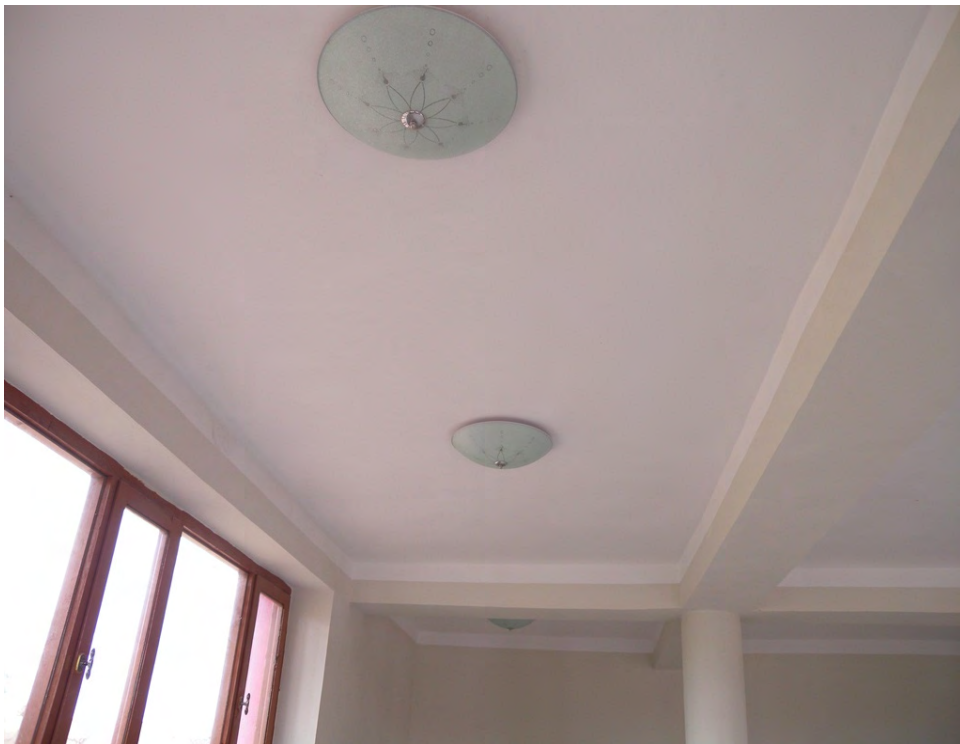
5. Installation of five (5) interior light fixtures and six (6) exterior light fixtures is complete. (See Figures 10, 11)
6. Installation of the ceramic tiles paving the interior floor is complete. This appears to be in accordance with the architectural renderings. (See Figure 12)

Figure 10. View of the interior lights on the ceiling of the CSC building

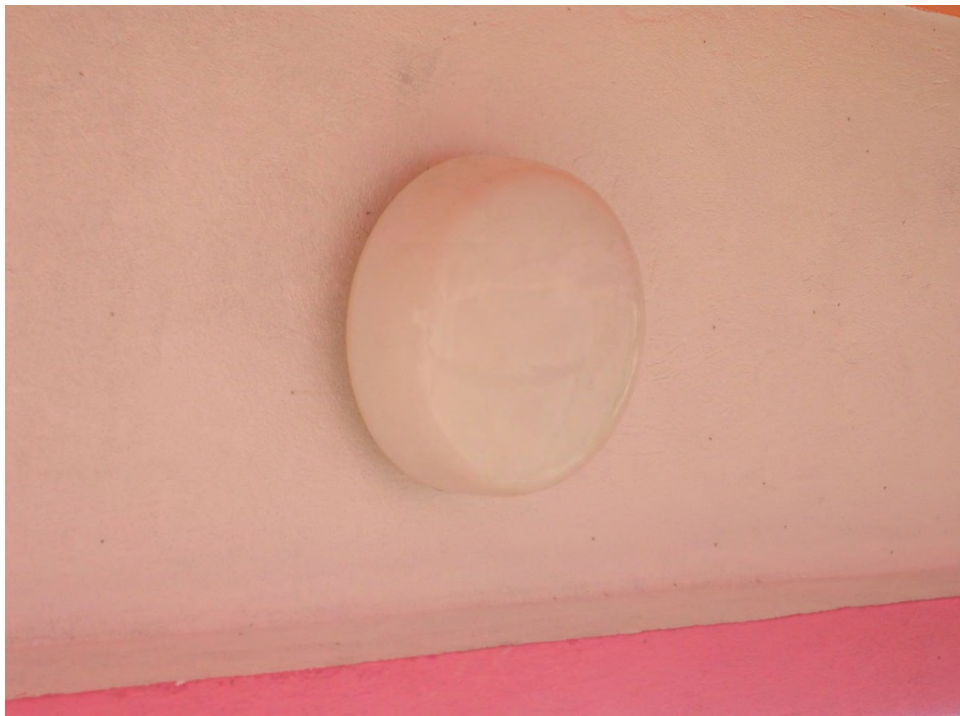
Figure 11. View of the exterior lights on the overhang outside the CSC building

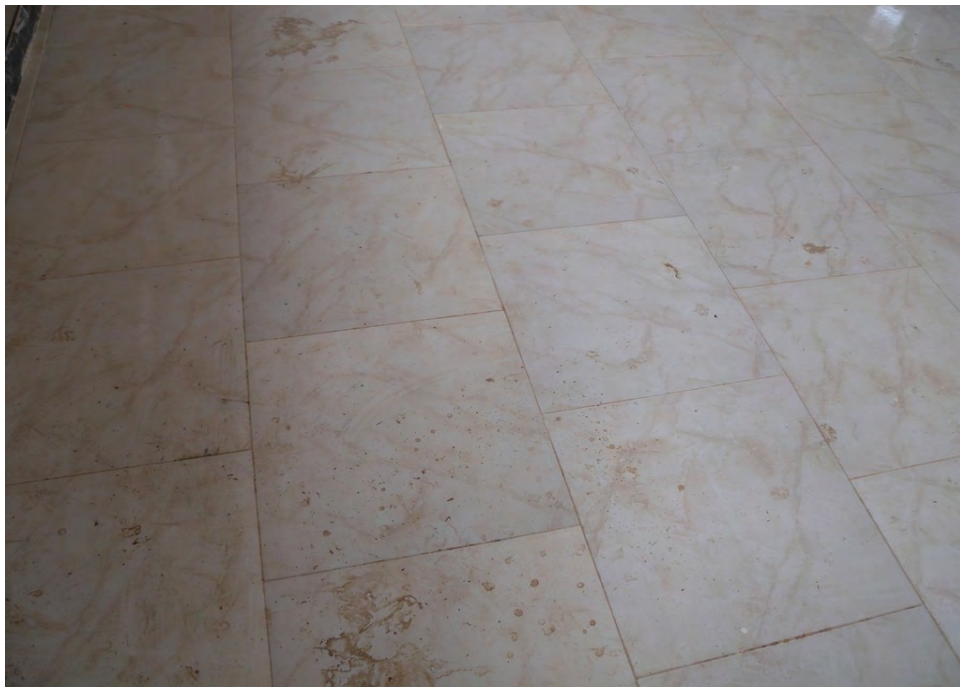
Figure 12. View of the interior ceramic tile flooring of the CSC building
